Case 493 : Narrative

Case Vehicle (A): 2003 BMW
Type: 330i, 4-door sedan
Driver: 33-year-old male
CDC: 12-FCEN-3, 05-BYEW-1

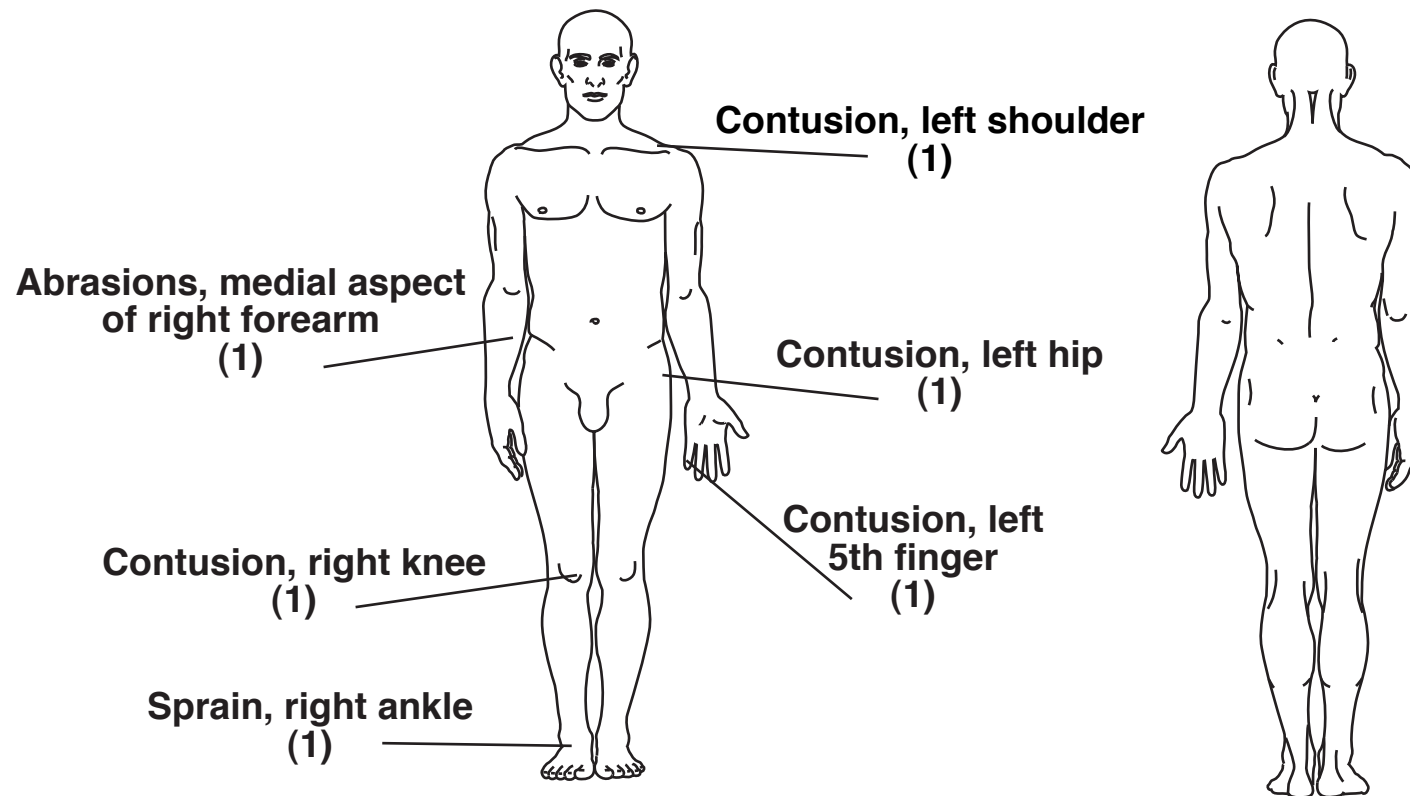
Occupant: Driver	Age: 33 years	Gender: Male		
Restraints: 3-point belt with pretensioner;steering-wheel airbag	Stature: 188 cm (6 ft, 2 in)	Mass: 79 kg (175 lb)		
Injury Description	A.I.S.	Injury Source		
—	—	Definite	Probable	Possible
Contusion, left shoulder	1	Shoulder belt	—	—
Contusion, left hip	1	Lap belt	—	—
Contusion, left 5th finger	1	Windshield	—	—
Abrasions, medial aspect of right forearm	1	—	Deploying airbag	—
Contusion, right knee	1	Knee bolster	—	—
Sprain, right ankle	1	—	Brake pedal	—
Maximum A.I.S. Level	1	—	—	—
Injury Severity Score	2	—	—	—
.12% blood alcohol level	—	—	—	—

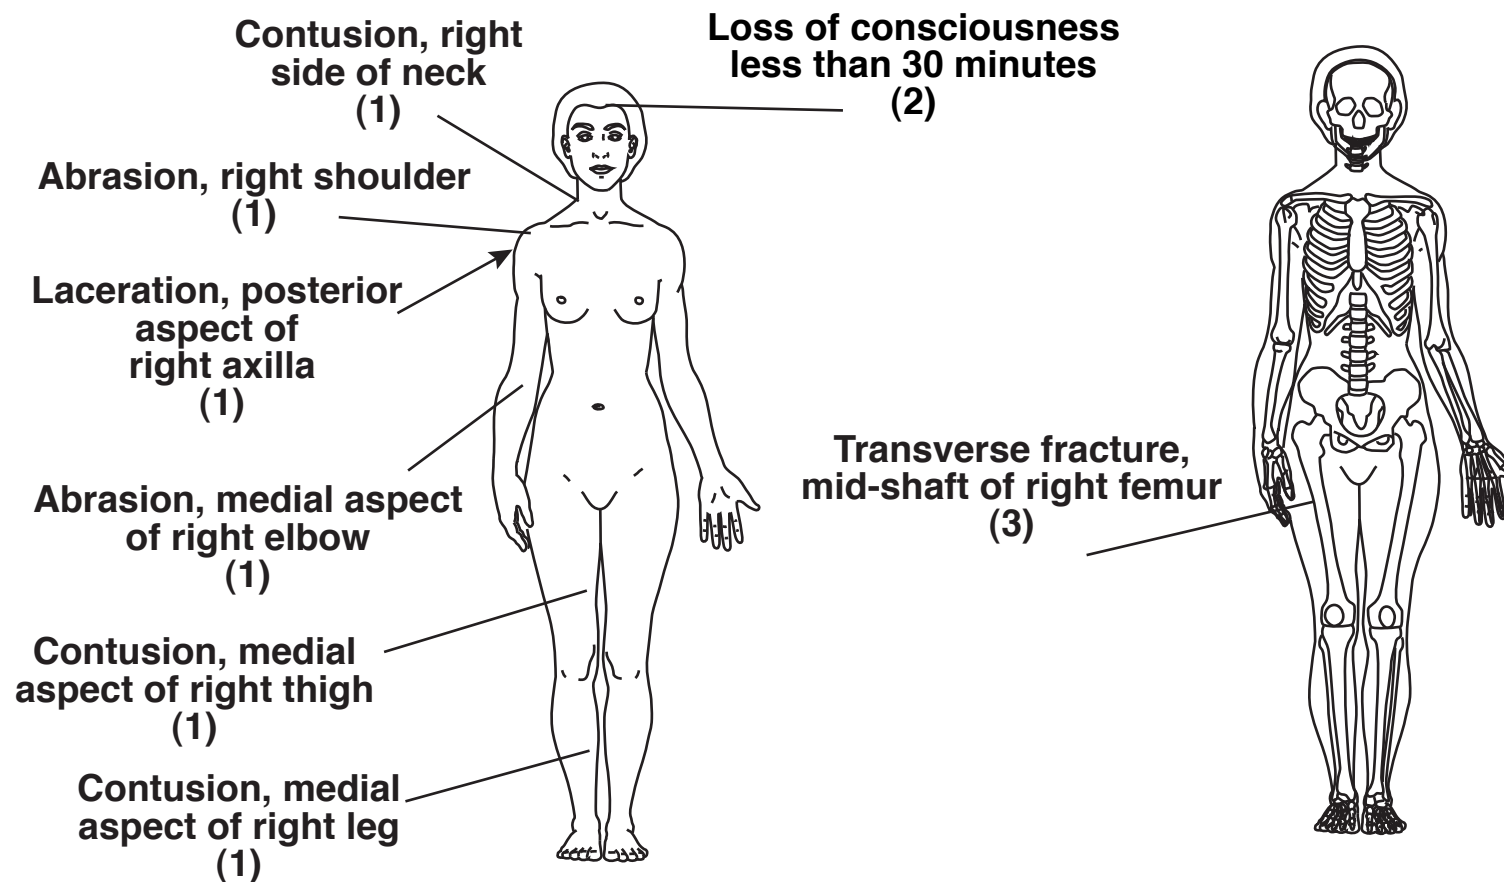
Injury Description	A.I.S.	Injury Source		
—	—	Definite	Probable	Possible
Loss of consciousness less than 30 minutes	2	—	Non-contact impact forces	—
Contusion, right side of neck	1	Shoulder belt	—	—
Abrasion, right shoulder	1	Shoulder belt	—	—
Abrasion, medial aspect of right elbow	1	—	Deploying airbag	—
Laceration, posterior aspect of right axilla	1	—	—	Interior of right-front door
Transverse fracture, mid-shaft of right femur	3	Knee bolster/glove compartment	—	—
Contusion, medial aspect of right thigh	1	—	Left thigh	—
Contusion, medial aspect of right leg	1	—	Left leg	—
Maximum A.I.S. Level	3	—	—	—
Injury Severity Score	14	—	—	—
.12% blood alcohol level	—	—	—	—

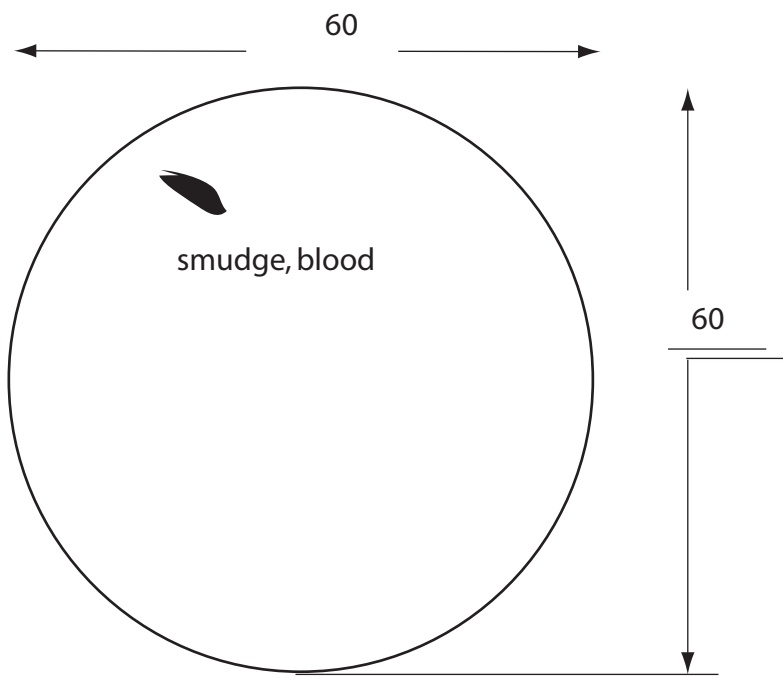
Driver Airbag

In the driver area, there was no damage to the deployed steering-wheel airbag or to the [28](#) airbag module cover, but [29](#) there was a smudge of blood on the upper-left section of the airbag fabric. [30](#) [31](#) The upper half of the steering-wheel rim was deflected forward but there was no damage to the spokes and there was no rotation of the steering column. [32](#) The upper and mid sections of the instrument panel and the

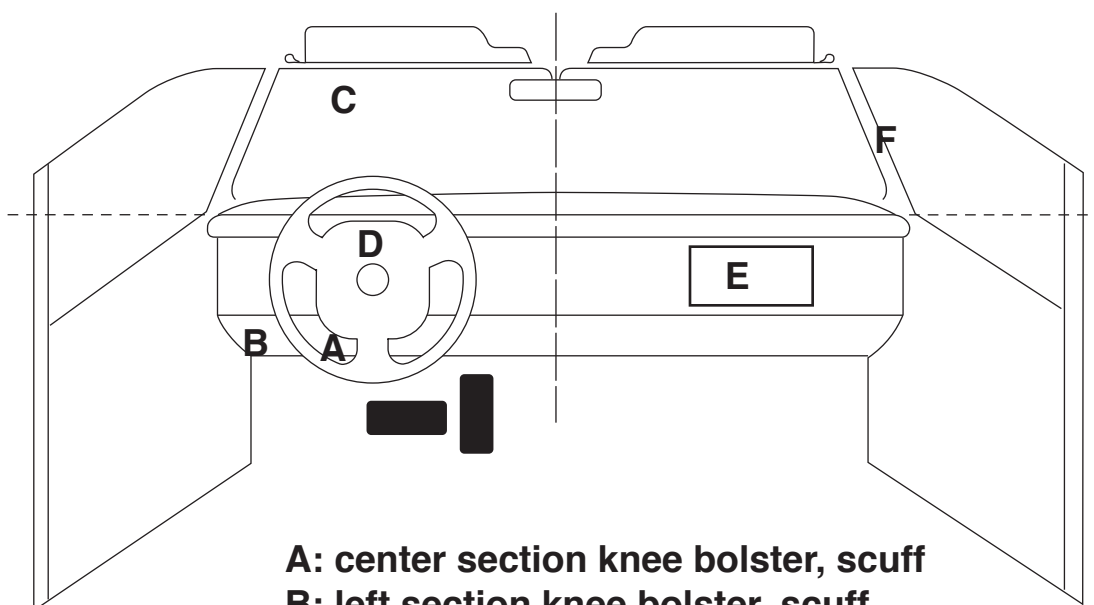
- A: center section knee bolster, scuff**
- B: left section knee bolster, scuff**
- C: windshield, crack**
- D: airbag, blood**
- E: glove box, scuff**
- F: A-pillar, scuff**

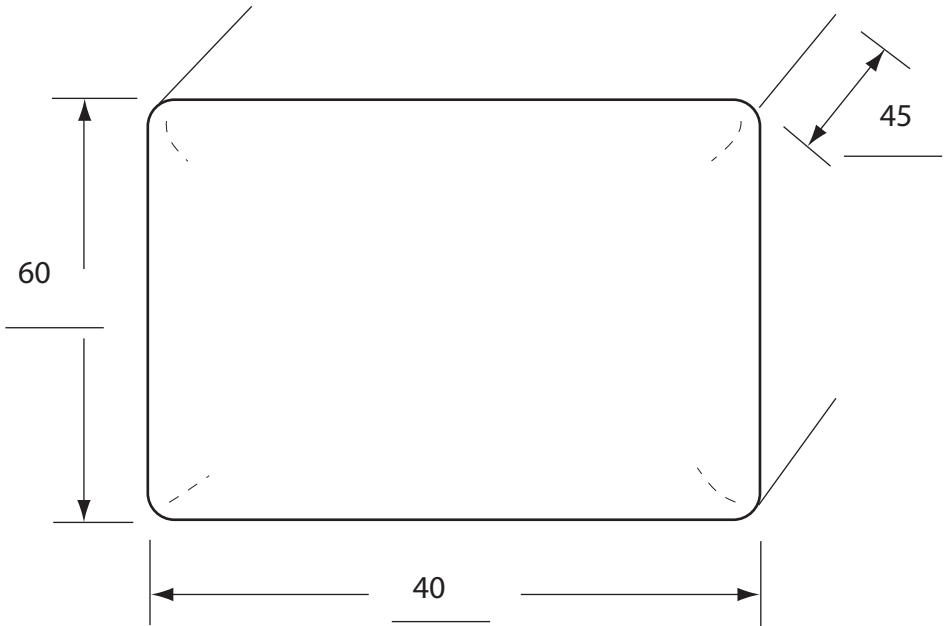
Passenger Airbag

[39](#) In the right-front seating area, the entire dashboard was damaged and displaced rearward, [25](#) [40](#) but there was no damage to the deployed dash-mounted airbag or the module cover. The upper panel and the dashboard trim were completely separated from their attachments. [41](#) There was a scuffmark on the glove-box door, which was damaged and would not fully close, and [42](#) the trim below the glove box was separated from its attachments. [43](#) The toe pan was displaced rearward and the floor was displaced up. [39](#) There was no damage to the A-pillar but there was a scuffmark on the pillar cover. The right-front door had been removed but it was not damaged. There was no other damage in the right-front area.
